RESTORING RAISED BOG IN IRELAND
Project Reference: LIFE04 NAT/IE/000121

A REPORT ON THE RESTORATION OF PROJECT SITE No. 3

CURRAGHLEHANAGH BOG, Co. GALWAY

**Compiled by: John Derwin,
Project Ecologist,
September 2008**

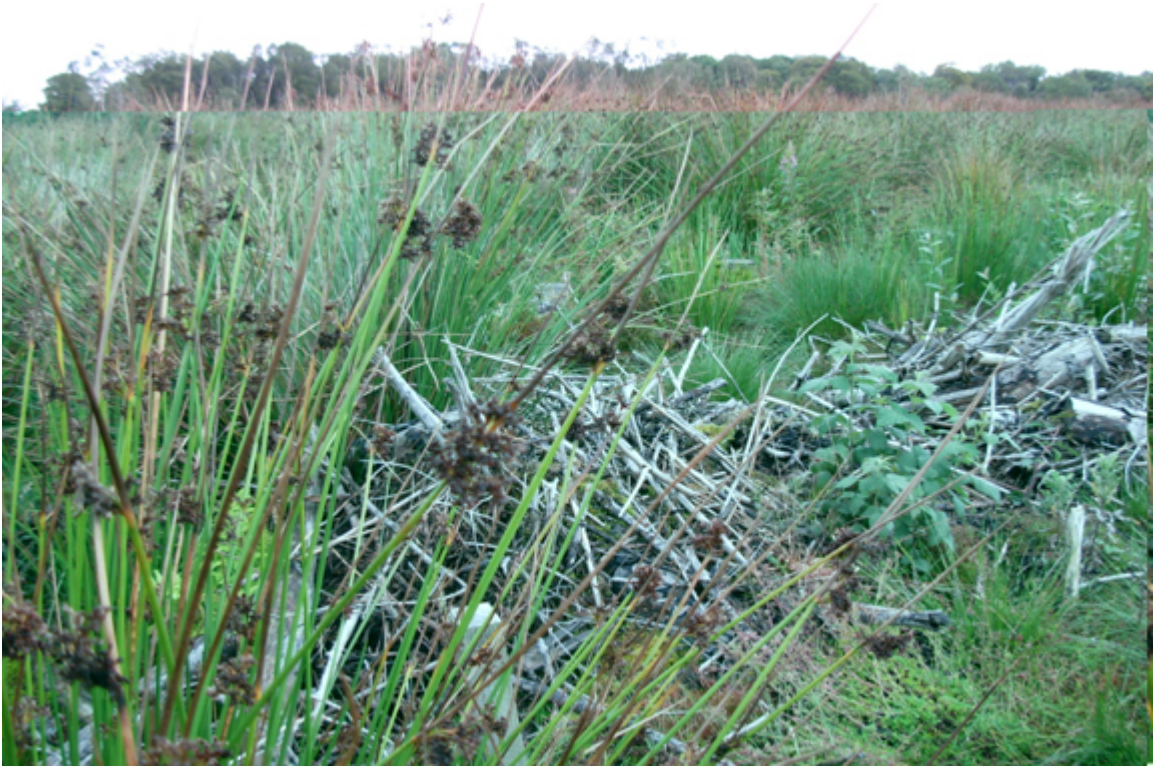
Curraghlanagh Quadrat 1, 2008

Quadrat 1: This quadrat is located on the western margin of Curraghelanagh Bog and occurred under closed canopy conifer plantation on high bog with vegetation containing Purple Moor-grass, Soft Rush and some *Sphagnum* moss, but mainly dominated by brash.

With the clear-felling of conifers and blocking of drains, Soft Rush, Ling Heather and Hare's-tail Cottongrass became established. Over time, *Sphagnum* cover will increase and this wet bog margin will develop raised bog habitat. However the dominance of Soft Rush may need to be controlled.

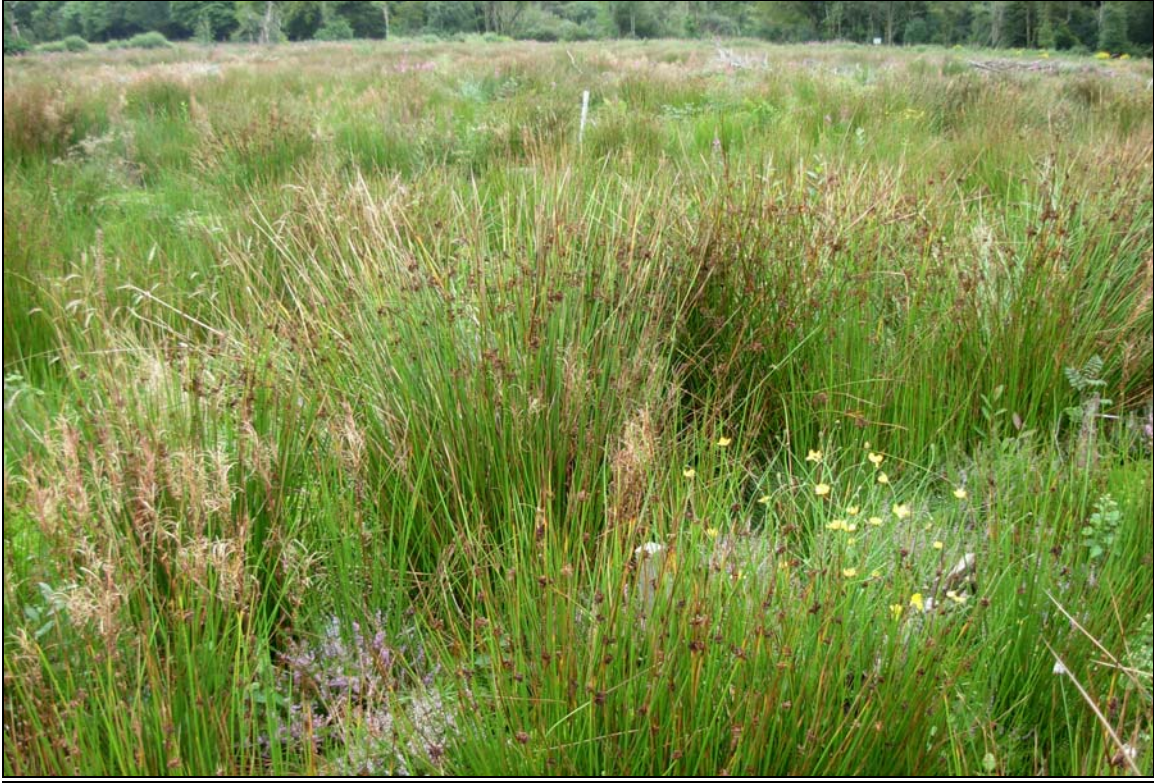
Curraghlanagh Quadrat 2, 2008

Quadrat 2: This quadrat is located on the north-western margin of Curraghlanagh Bog and occurred under closed canopy conifer plantation on cutover bog with vegetation containing *Hypnum* and *Sphagnum* moss, but is mainly dominated by brash and pine needles. With the felling of conifers and blocking of drains, Ling Heather has become established, but Soft Rush now dominates the vegetation. The dominance of Soft Rush indicates that peat depths are shallow at this location and that Lagg vegetation will become established here.

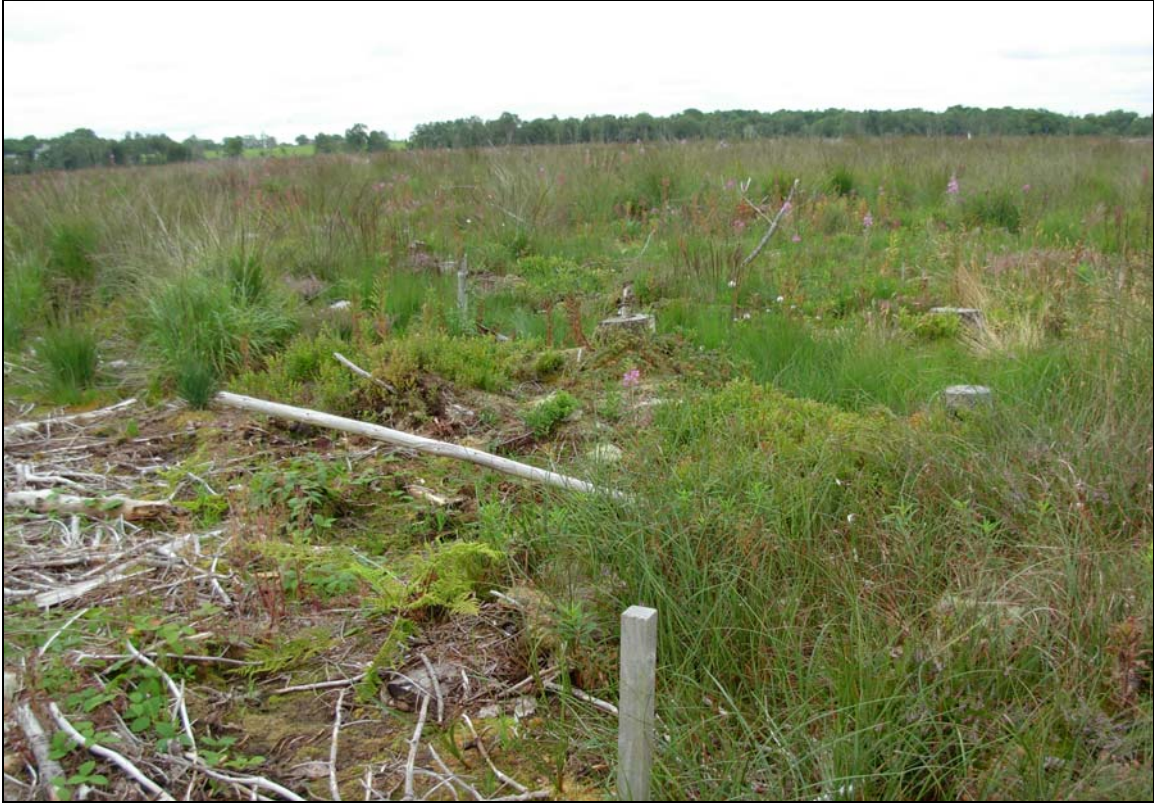
Curraghelanagh Quadrat 3, 2008

Quadrat 3: This quadrat is located on the southern margin of Curraghelanagh Bog and occurred under closed canopy conifer plantation high bog with vegetation containing Purple Moor-grass, Bilberry and *Hypnum* moss. With the felling of conifers and blocking of drains, Ling Heather and Bilberry cover increased. Over time, *Sphagnum* cover will increase and this wet bog margin will develop into raised bog habitat.

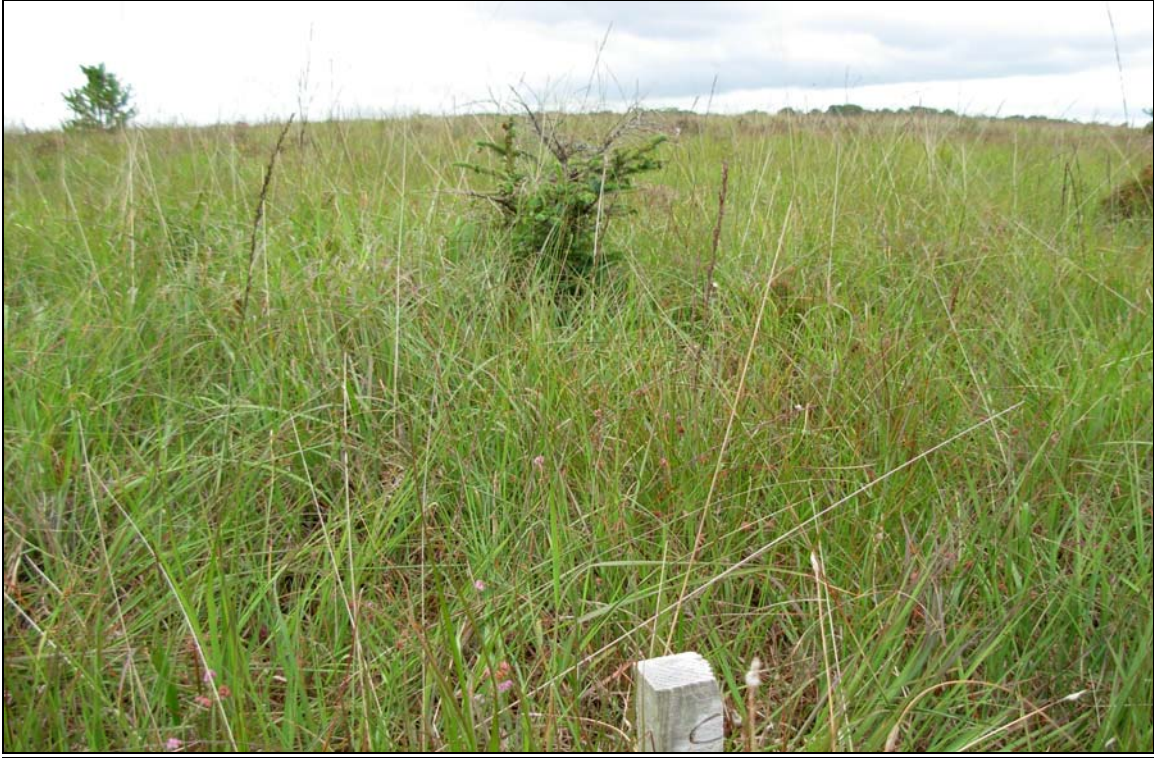
Curraghlanagh Quadrat 4, 2008

Quadrat 4: This quadrat is located on the southern margin of Curraghelanagh Bog and occurred on open high bog with vegetation containing Purple Moor-grass, Ling Heather, Cross-leaved Heath, and Hare's-tail Cottongrass with some *Sphagnum* moss. With the blocking of drains on adjacent plantations, *Sphagnum* cover may increase and over time, the raised bog habitat of this wet bog margin will be protected.

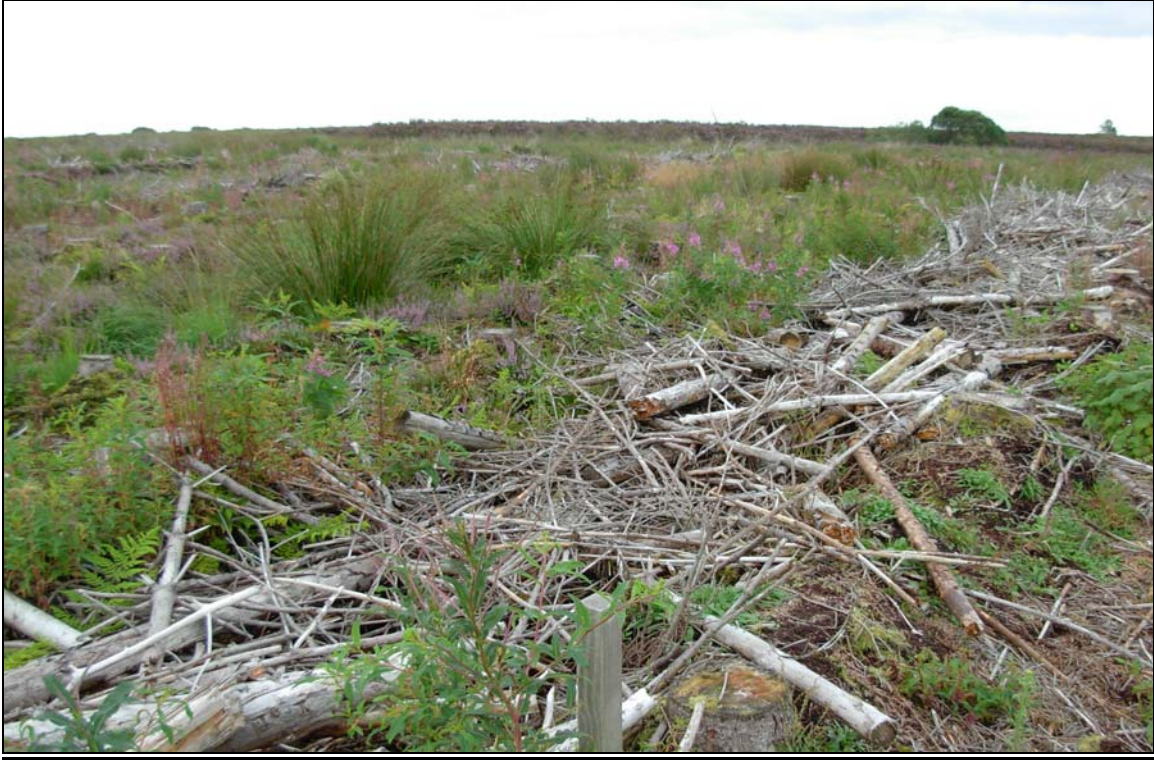
Curraghlanagh Quadrat 5, 2008

Quadrat 5: This quadrat is located on the south-western margin of Curraghelanagh Bog and occurred under closed canopy plantation on high bog with vegetation containing *Hypnum* moss, but is mainly dominated by brash and pine needles. With the felling of conifers and blocking of drains, Ling Heather and *Sphagnum* cover increased and over time, this wet bog margin will develop raised bog habitat.

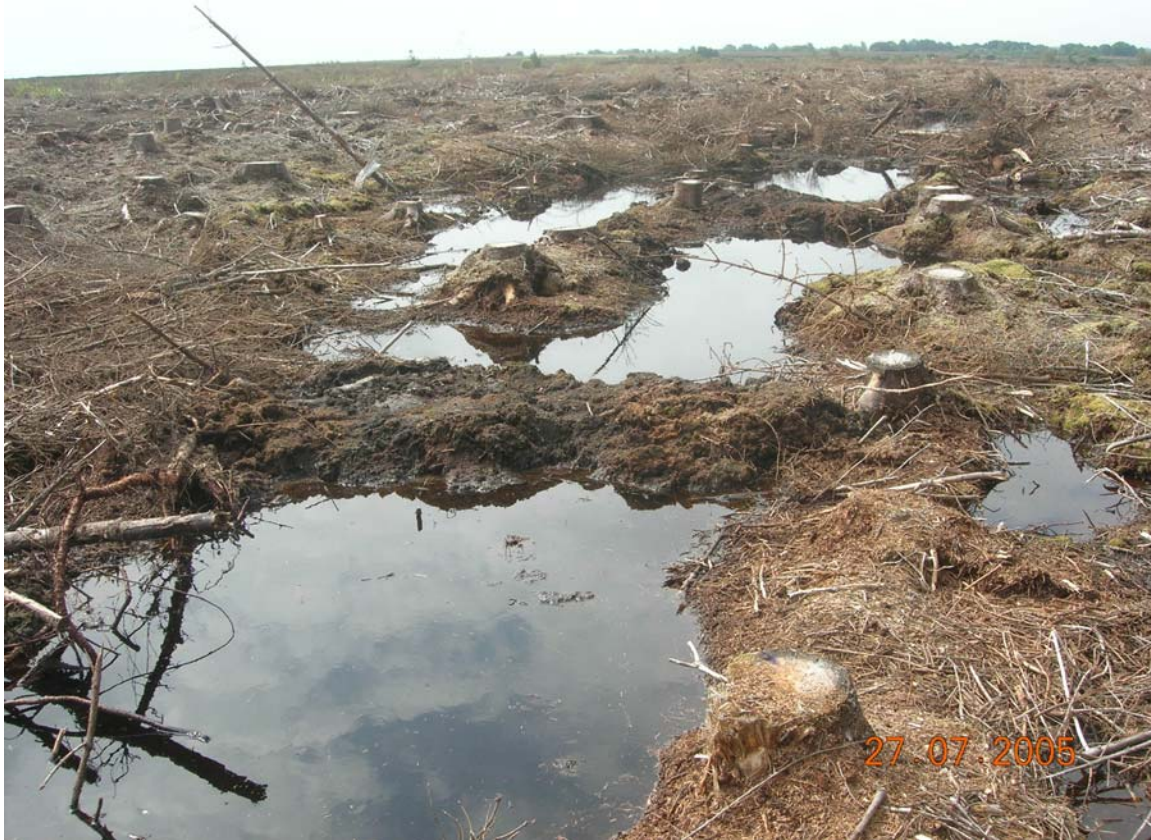
Prior to restoration, Walrags were installed in the conifer plantation to record any changes in water-levels, due to tree removal and drain blocking. Water-levels were found to be up to **50cm** below the surface. With the removal of conifers and drain-blocking, there was a rise in the water-table in the plantations on the high bog and the water-table remains close to the bog surface throughout most of the year.

During the clear-felling operation, eight Walrags were installed on this site to record the changes in water-levels. The rise in water-levels is clearly seen in the following graphs.

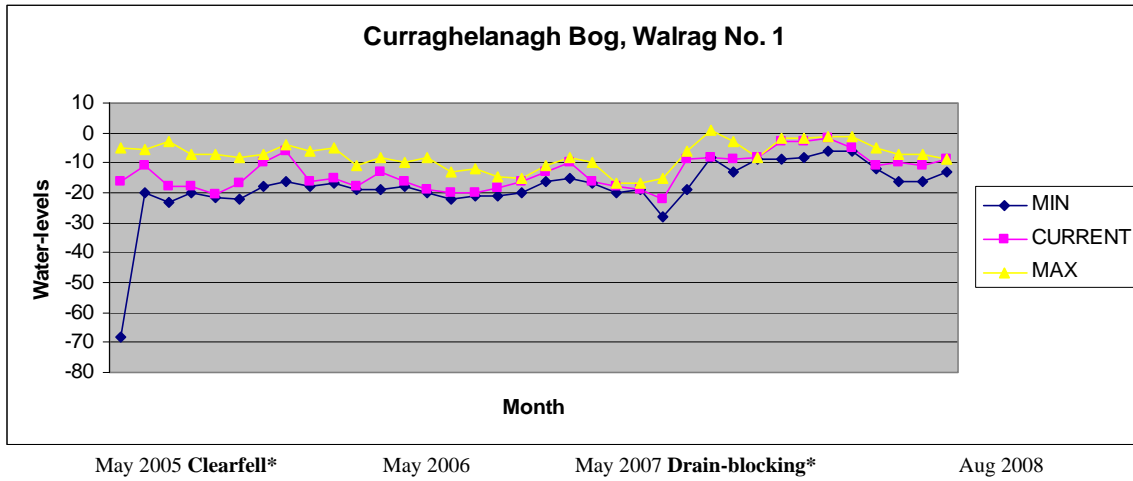
Curraghelanagh Bog Walrag 1: Clearfell on Cutover Bog

(Water-levels within 10 cm of bog surface post restoration*, lower in summer)

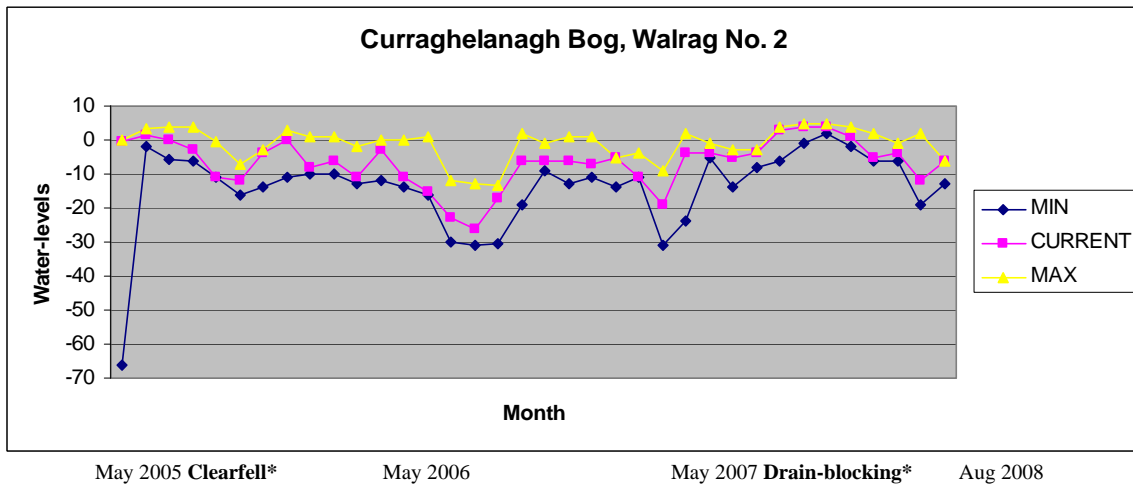
Curraghelanagh Bog Walrag 2: Clearfell on High Bog

(Water-levels within 10 cm of bog surface post restoration*, lower in summer)

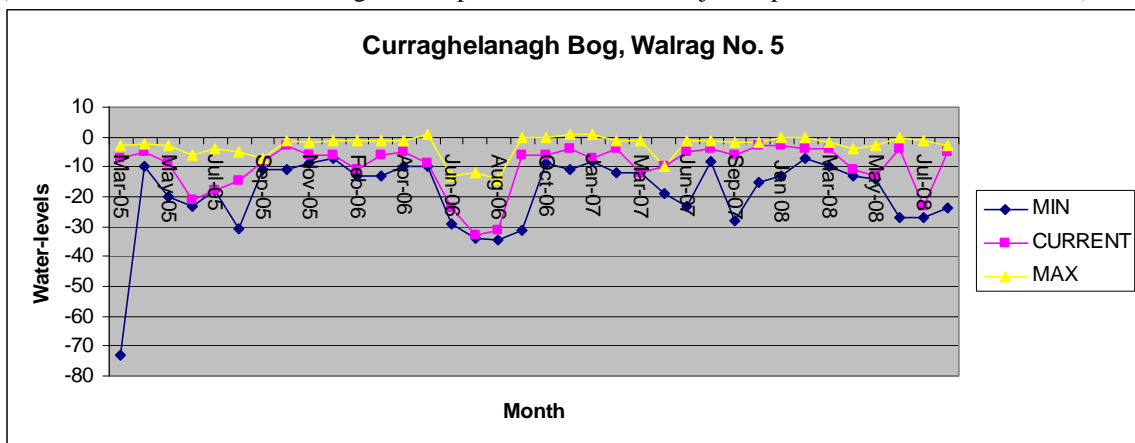
Curraghelanagh Bog Walrag 5: Open High Bog

(Water-levels within 10 cm of bog surface post restoration* on adjacent plantations, lower in summer)

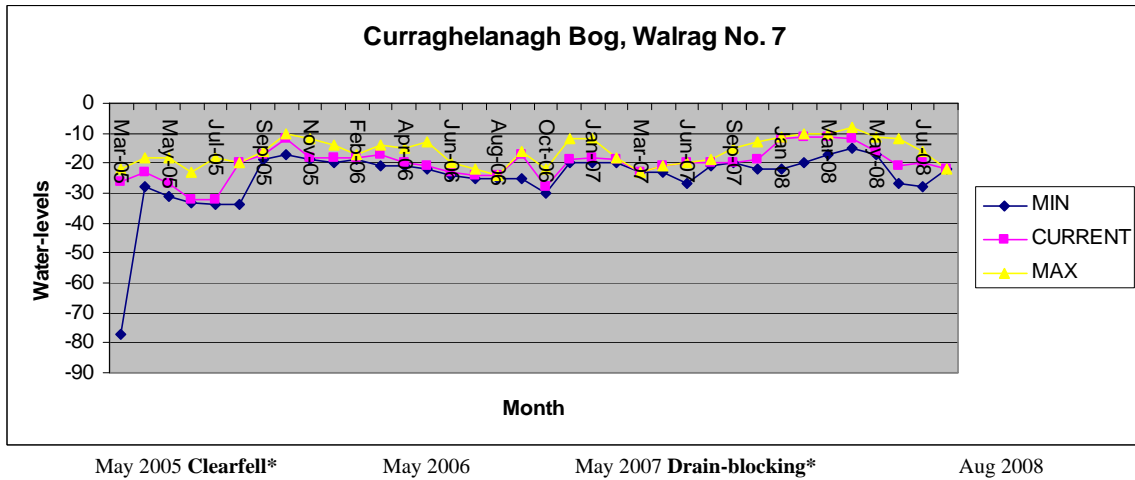
Curraghelanagh Bog Walrag 7: Clearfell on High Bog
 (Water-levels within 20 cm of bog surface post restoration*, lower in summer)

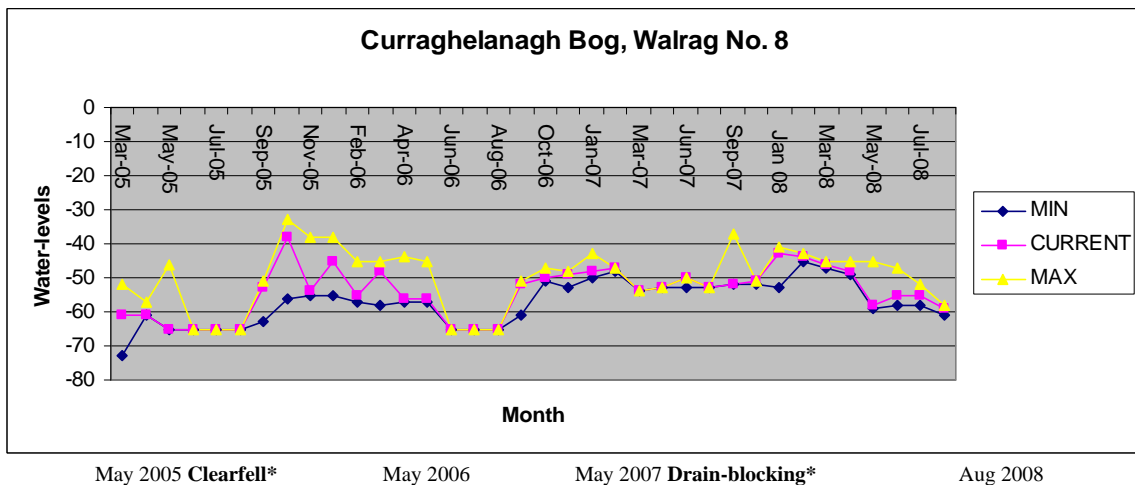
Curraghelanagh Bog Walrag 8: Clearfell on Cutover Bog
 (Water-levels 50 cm below bog surface post restoration*, due to shallow peat depth)
